Subject: John R Street Site Assessment
Highland Park, Wayne County, Michigan
Technical Direction Document Number: S05-0001-1007-013
Document Control Number: 1137-2A-AIMG
Work Order Number: 20405.012.001.1137.00

John R Street Site Assessment
February 18, 2011

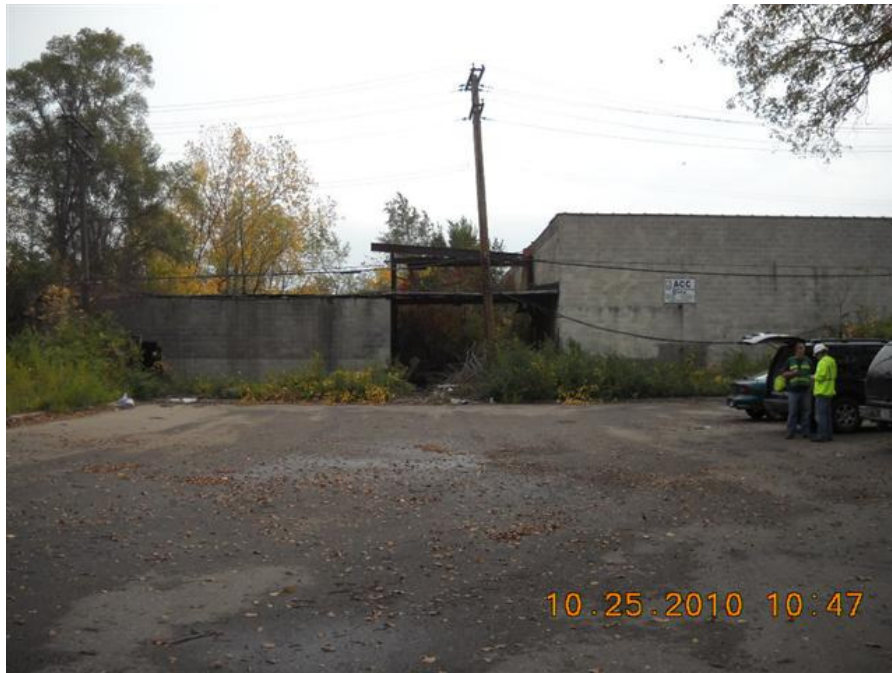
Photograph No.: 1

Subject: Entrance to the Site building from the northern parking lot

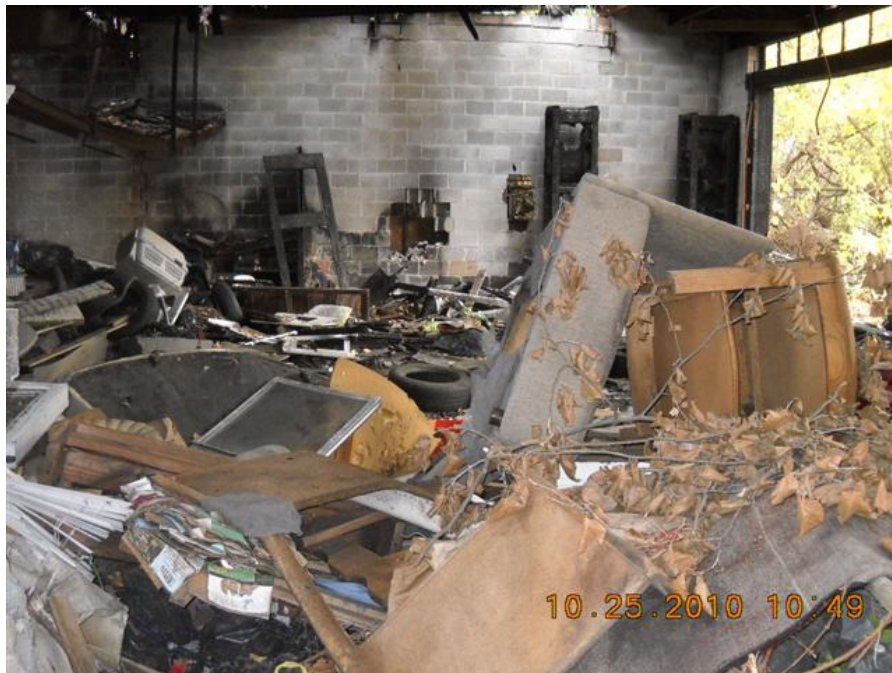
Photograph No.: 2

Subject: Trash and debris in a room inside the Site building

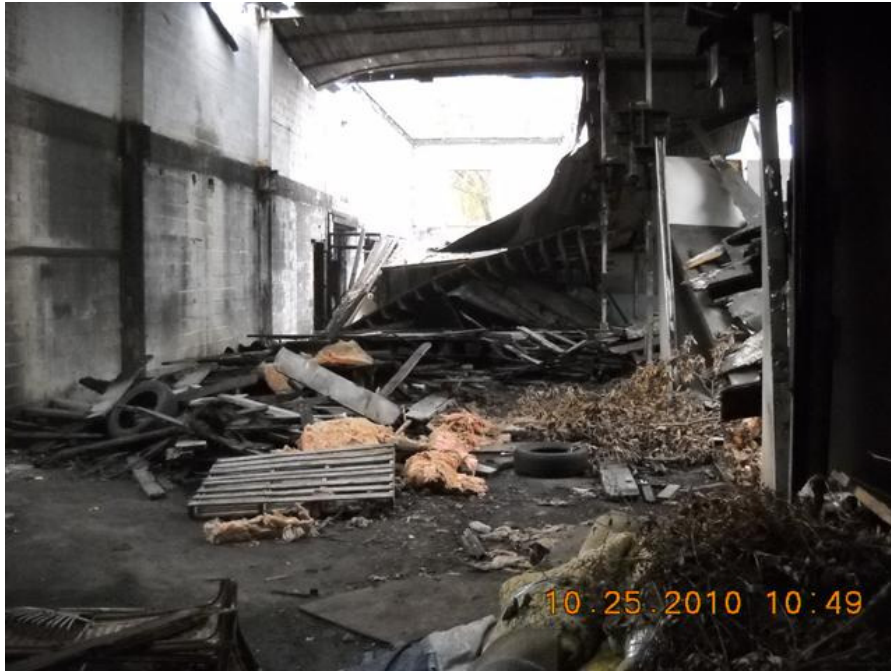
Photograph No.: 3

Subject: Debris and evidence of structural instability inside the Site building

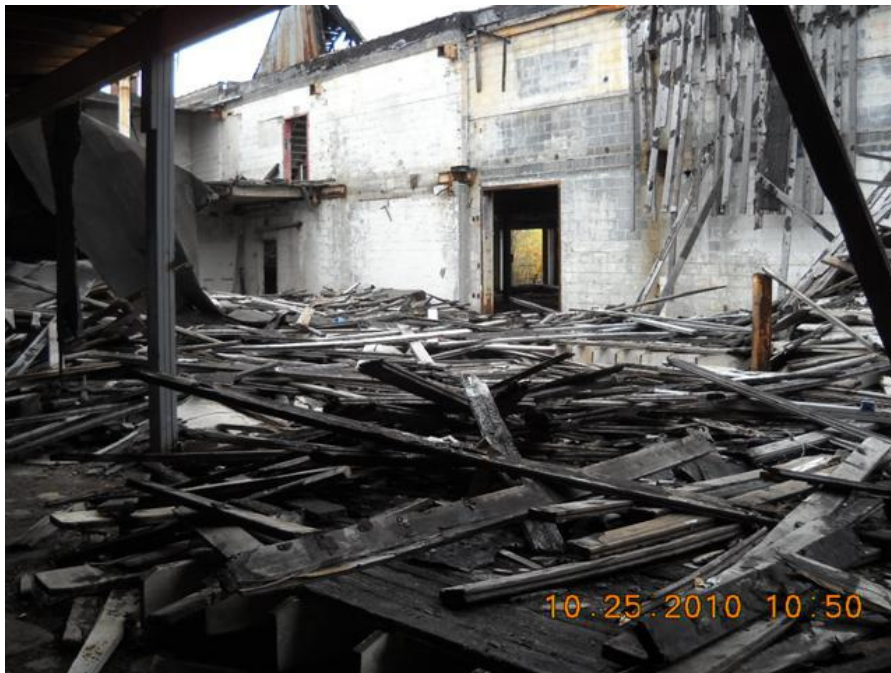
Photograph No.: 4

Subject: Building debris and evidence of structural instability inside the Site building

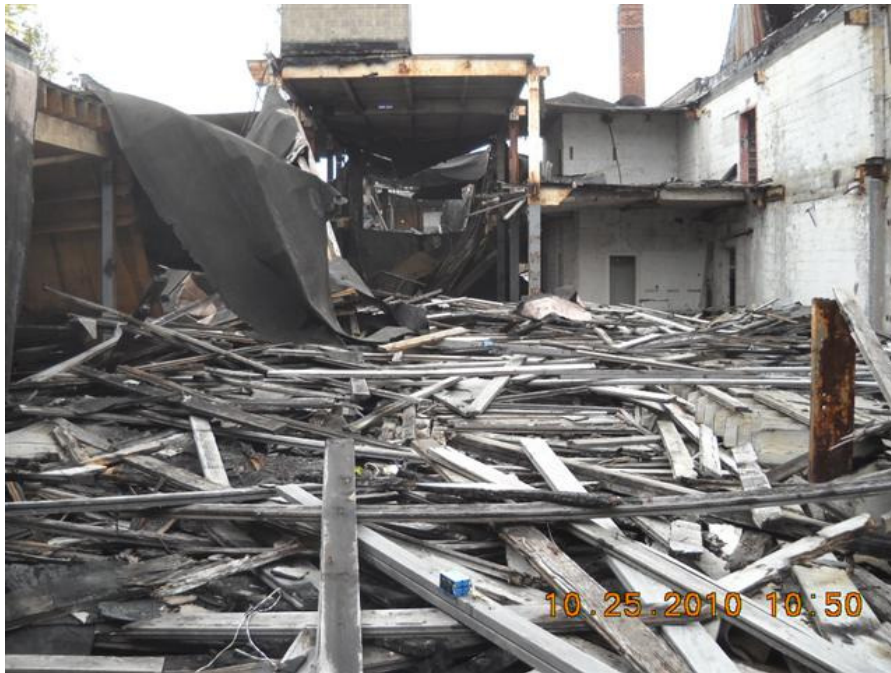
Photograph No.: 5

Subject: Building debris and evidence of structural instability inside the Site building
